# Robinette Emergency Response

## Condo Fire

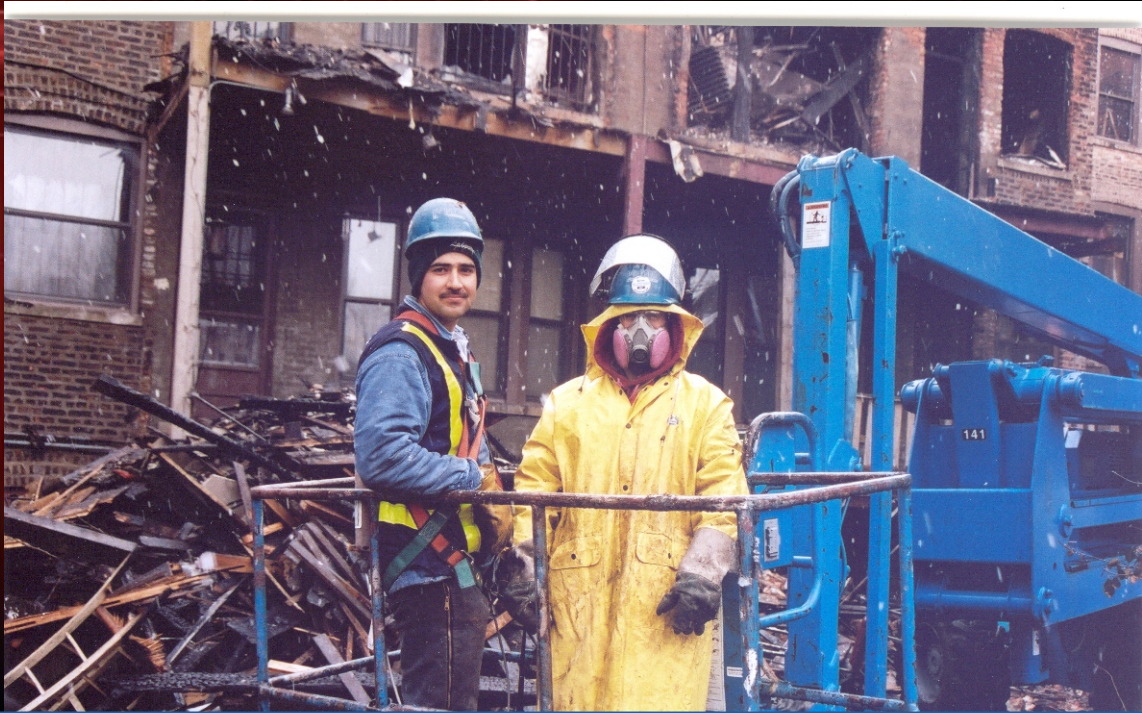
In late January a three-story condominium was left a charred heap after a small fire began in a single unit and spread to the bulk of the structure. The fire department reacted quickly and although significant fire damage occurred to the contents of the building and the wooden structural components, engineers felt that the center and exterior brick of the largely masonry building might be salvageable.

Structural engineers called Robinette's Emergency Response Division to assess the possibility of salvaging the masonry portions of the building. Protective shoring was needed to ensure the stability of the walls and prevent further collapse, and the fire debris needed to be removed from burnt areas so that the building could be restored.

A crew of 20 Robinette laborers carefully stabilized the damaged building prior to removing brick and other miscellaneous debris from the center of the structure. A crawler crane was maneuvered into the tightly enclosed area at the rear of the building, and positioned for debris removal. Using two skid-steers, and a 60 foot boom lift, our team created a safe and efficient job environment, disposed of 1100 yards of debris, and saved the salvageable portions of the building for re-use.
